# **Cladding Deflection Evaluation for Wayne Building Products Lux Panel**

# Cladding Deflection Evaluation for Wayne Building Products Lux Panel Final Client Report

Report No: A1-008208-01.1  
Report Date: 4 April 2016  
Contract No: A1-008208-01  
Agreement date: 11 January 2016  
Program: Building Regulations for Market Access

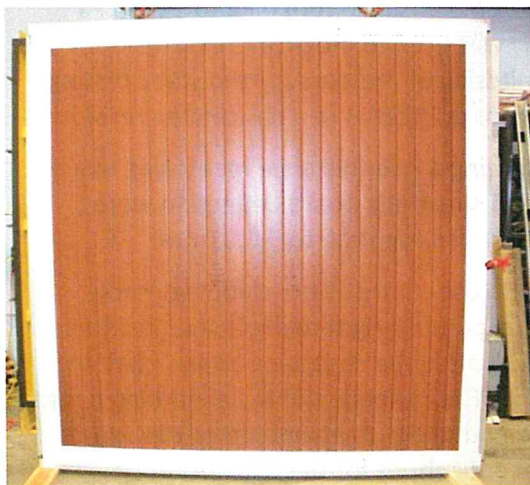
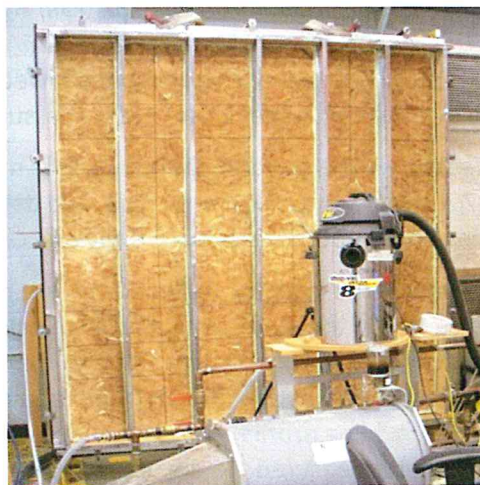
Figure 1: Photos of cladding deflection test specimen showing exterior (left) and interior (right)

The specimen used in the evaluation was constructed by the client and shipped to NRC; it was received on January 5, 2016. It measured 2.44m by 2.44m (8-ft. x 8-ft.) and consisted of non-load bearing steel studs spaced at 400 mm (16-in.) on center, with OSB as the sheathing board. The OSB sheathing was butt jointed at the vertical centre of the wall (1.22 m, 4-ft.). The specimen is shown in Figure 1.

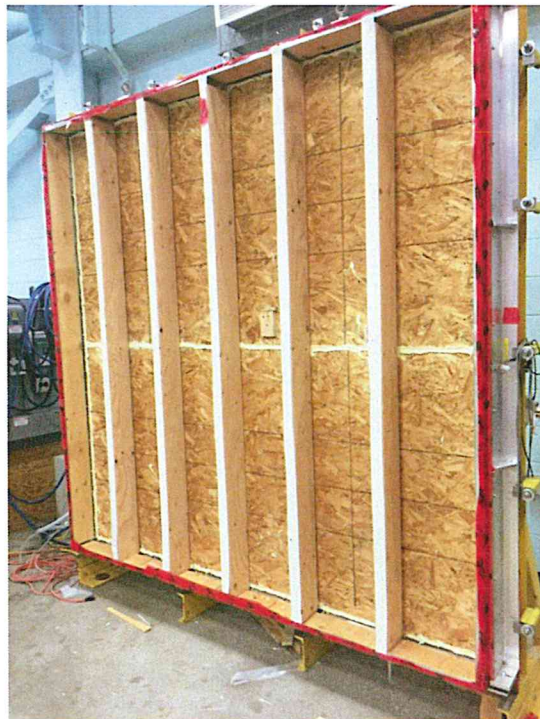
Figure 10: The buckled studs were straightened and reinforced with 3/4in plywood strapping so that the cladding deflection tests could be completed.

During the portion of the test where negative cyclic loads acted on the test specimen, the steel studs on one side of the specimen buckled in their center height at approximately -800 Pa pressure. To complete the cladding deflection test, these studs were thereafter reinforced with plywood horizontal strapping. As the purpose of this evaluation was determining cladding deflection under loads, and not deflections of the test specimen, no assumptions are made regarding the performance of this wall configuration under field loading conditions. However, care should be taken to ensure that the steel stud gauge is properly selected for the expected wind loads in a full scale wall design. Photos of the buckled steel studs and plywood strapping that were used in the test are shown in Appendix B. Through visual observation the buckled studs did not have any effect on the cladding.

locations. Visual and measurement results of the cladding after testing showed that no permanent deterioration or fracture of the cladding occurred during testing. The measured deflection results showed that the maximum cladding deflection during testing was 4.70mm. It should be noted that although the cladding suffered no permanent deflection or visually apparent degradation during testing, this was not the case for the steel studs. During negative load testing the steel studs on one side of the specimen buckled at their center, and subsequently required support of horizontal plywood strapping to complete the cladding deflection testing.
