## Technical Bullet Series on Clay Brick Pavers

### #3 - Efflorescence

*February 2009 (Updated January 2017) by Harold B. Newman, CrE*

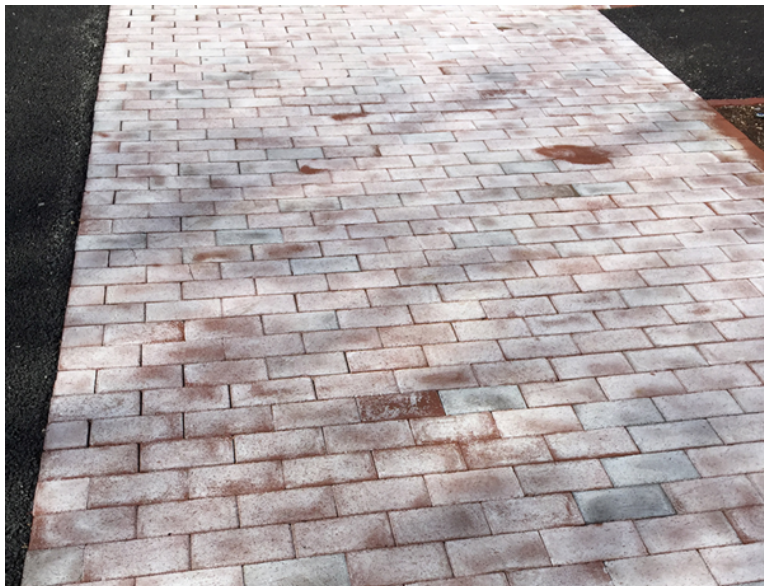
Picture: Efflorescence Caused By Rock Salt De-Icing Salt

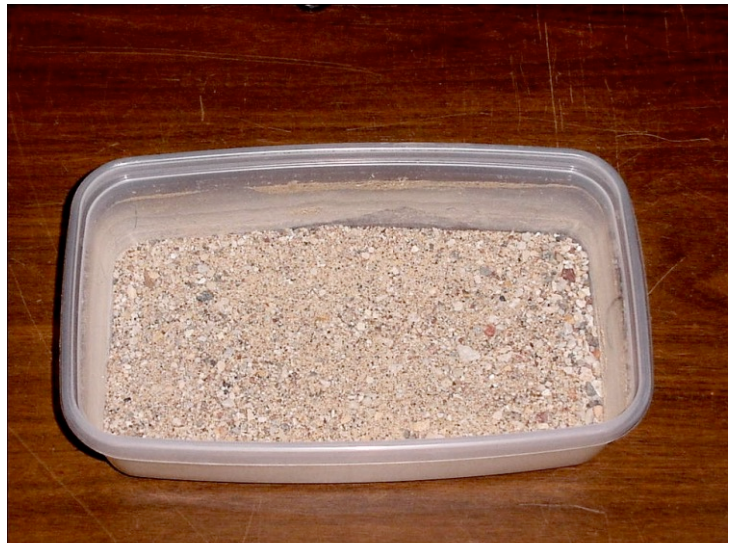
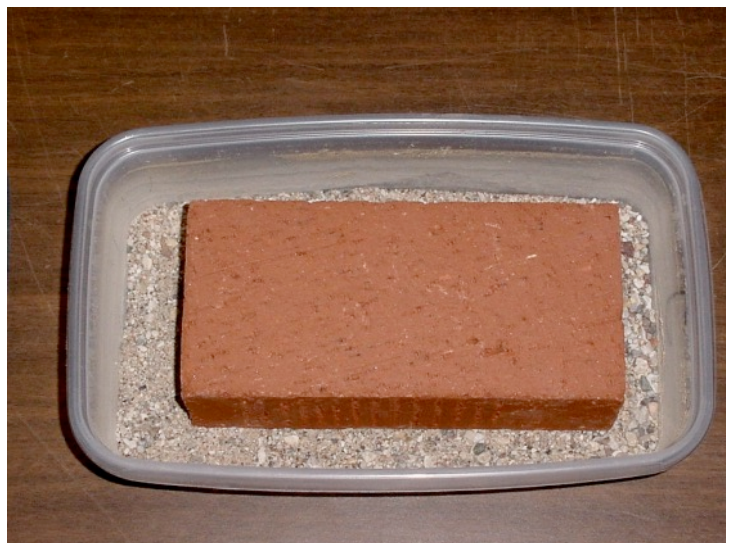
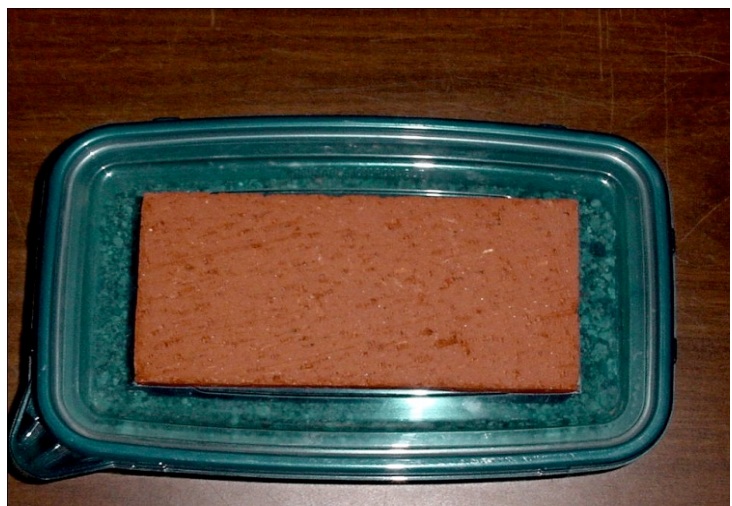
In these ongoing studies, various materials were tested for soluble salts measuring cation and anion concentrations using an ion chromatograph. A modified efflorescence test was run whereby clay pavers, which did not show any evidence of efflorescence in the normal ASTM C-67 test, were set on beds of the various aggregate samples set up in individual plastic dish containers. A fixed portion of distilled water was placed in the container and a plastic lid was cut to expose only the surface of the clay paver to evaporation. The containers were placed in a controlled atmosphere with a fan blowing across the surface of the dish. Following 7 days of exposure, the samples were removed and dried in an oven and evaluated for the evidence of efflorescence. Several dishes were also included which did not contain any setting materials. See pictures right and below. ***(Note: clay pavers used in this study were the Pine Hall Brick 4 x 8 Pathway units)***

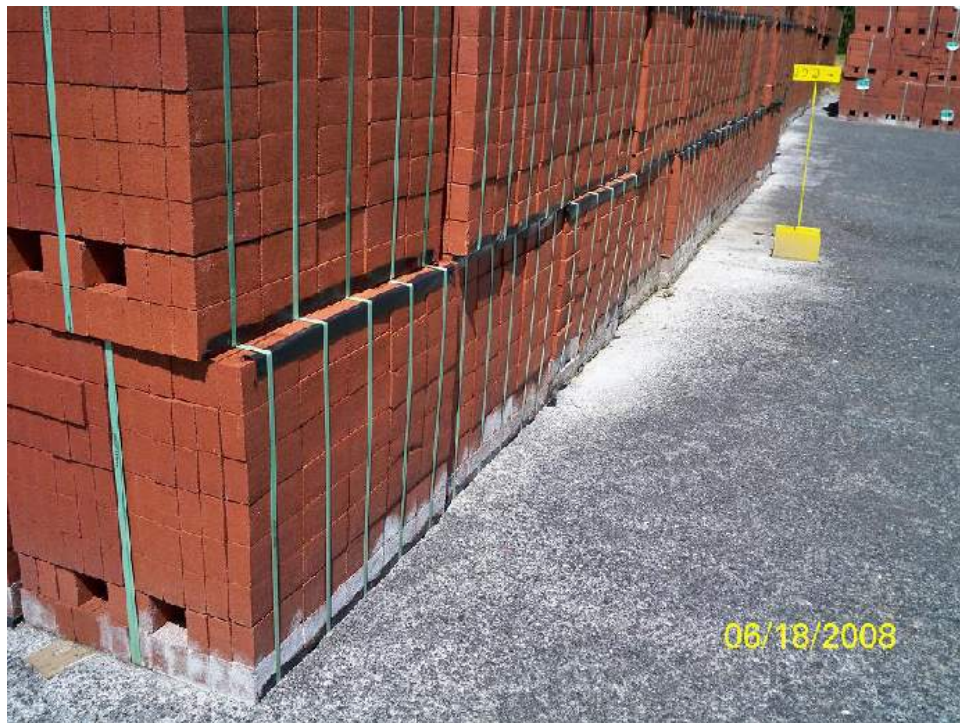
A good example of this would be when pavers are stacked on an aggregate base yard that is contaminated with soluble salts, either from it's virgin location, in transit to the point of deposition, or from de-icing salts. When the surface of the yard gets wet, the salts are dissolved in water and migrate into the stack of pavers. When the pavers dry out, the transported salt shows up on the surface as efflorescence.

Picture: Salts Migrating Up Cube from Contaminated Base

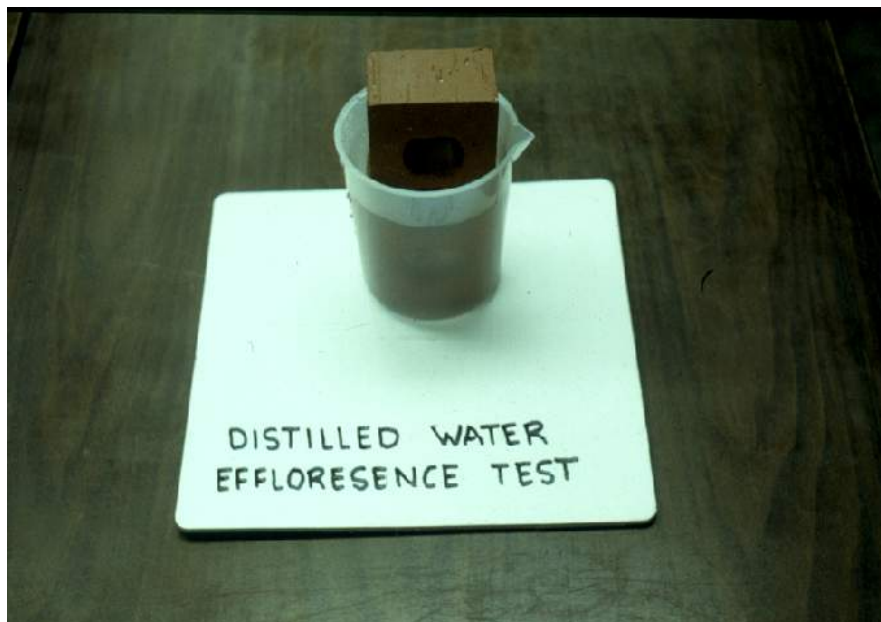
The efflorescence potential of fired clay products can be evaluated using the ASTM C-67 procedures. The clay product collected from the kiln prior to being subjected to the atmosphere is partially submerged in distilled water for as period of 7 days. Following the 7-day period the products are dried in an oven and evaluated for the presence of efflorescence. The tested products are compared to products that have not been subjected to the leaching test. When viewed from a distance of 10 feet, if there is no difference in the appearance of

the test samples and the standard sample the rating is “not effloresced”. If the samples show a perceptible difference due to efflorescence the rating is “effloresced”.

Picture: ASTM C67 Efflorescence Test

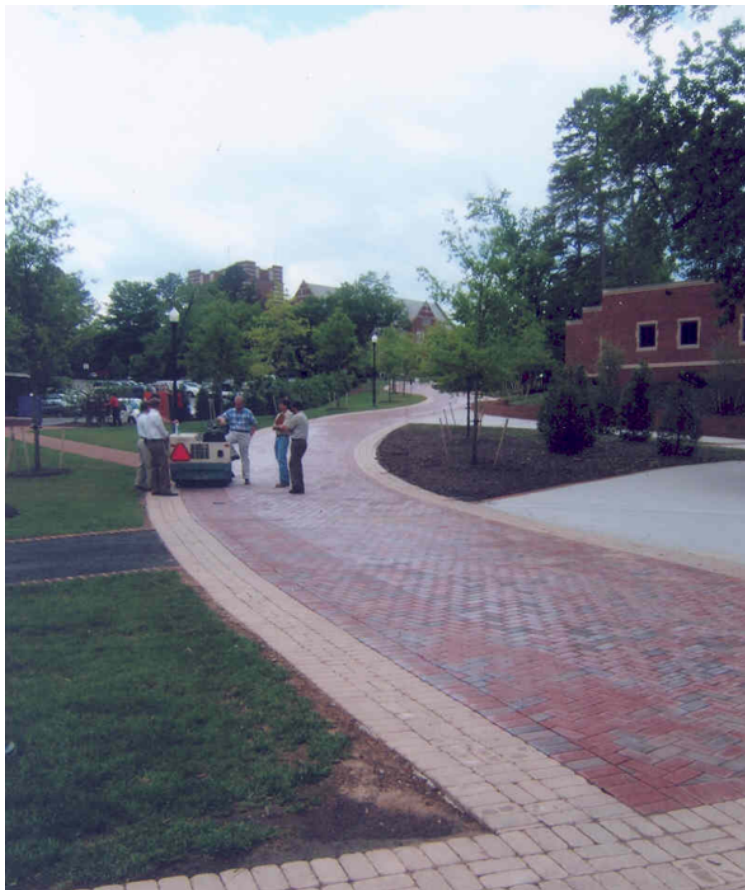
Picture: Efflorescence Vacuum

- Let mother nature run its course. If a pavement is sloped correctly efflorescence will naturally wash off the pavement and disappear over time depending on the amount of rain and severity of the efflorescence. This natural process can be accelerated with the use of a water hose and stiff bristle brush.
- Vacuum the salt powder using an industrial strength commercial cleaner. Then, flush the surface with water downgrade to wash the salt away from the pavement surface. This process might need to be repeated, after drying, as some salts can get reabsorbed into the paving system.
