**Test Report No: RJ6302P-1**

**SAMPLE ID:** The client submitted and identified the following test samples as:  
4 each, plastic pedestals approximately 22" high by 4½" in diameter.

**TEST REQUESTED:** Pedestal Axial Load Test per Section 5 of CISC Recommended Test Procedures for Access Floors.

## **PEDESTAL AXIAL LOAD TEST PER SECTION 5 OF CISCA**

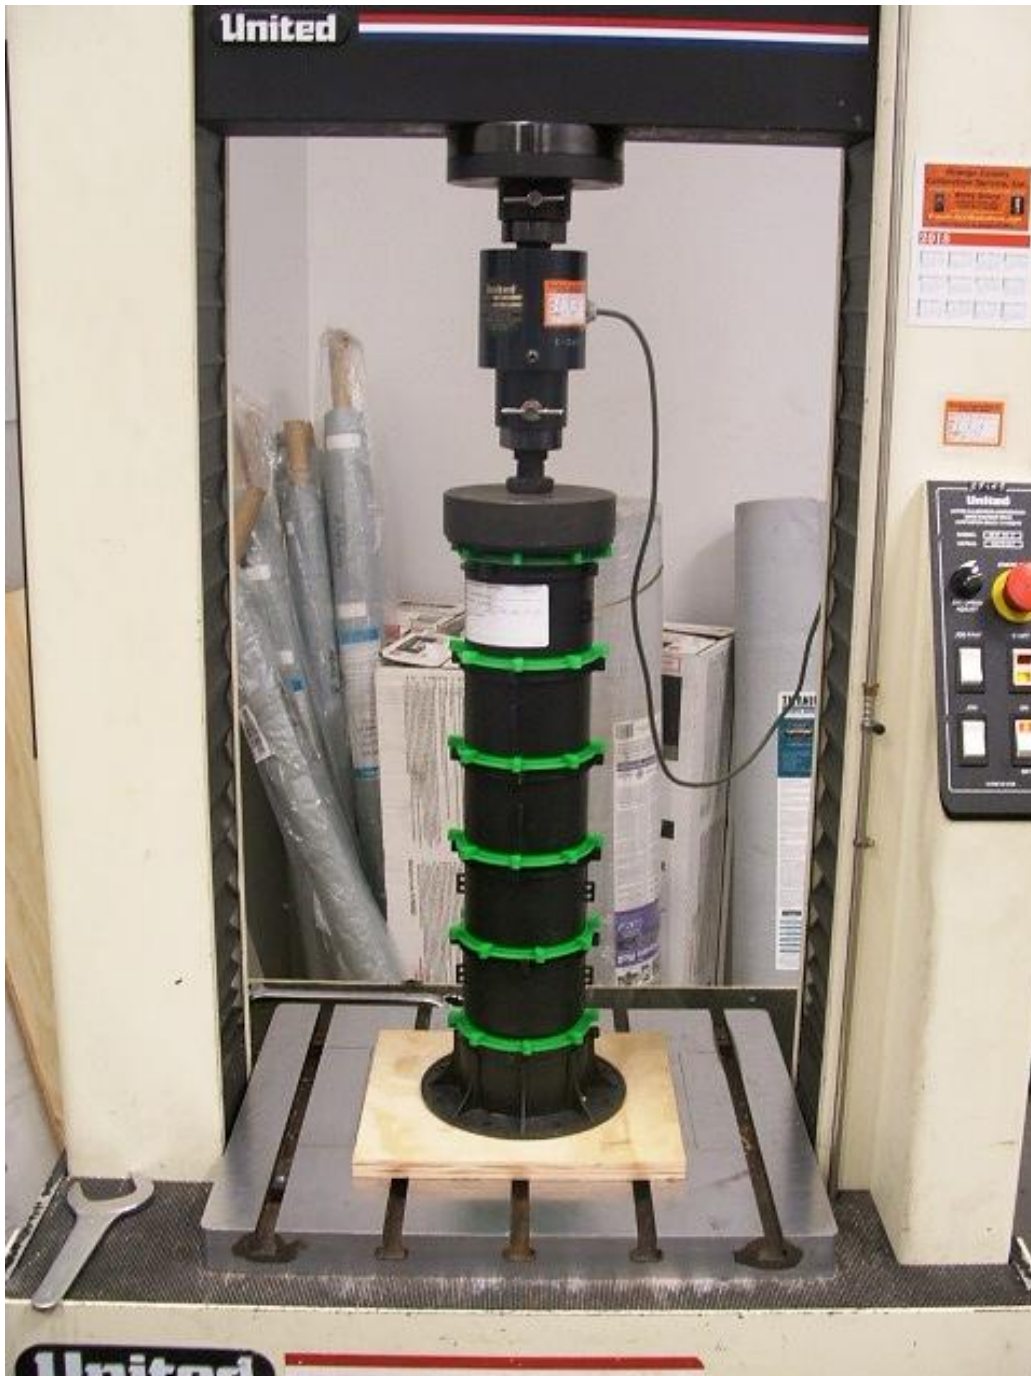
Photograph No.1  
22" Pedestal Axial Load Test Set-up

The test specimens were individually placed on a steel platform centered on a United compression/tension machine. An axial load was applied to the top of the specimen at a rate not exceeding 10,000 pounds per minute (44.5 kN/min) up to a load of 3,500 pounds (15.6 kN). The load was held for a minimum of 1 minute, released, and the test specimen examined for damage. A photograph of the test set-up is provided on page 3 of this report.

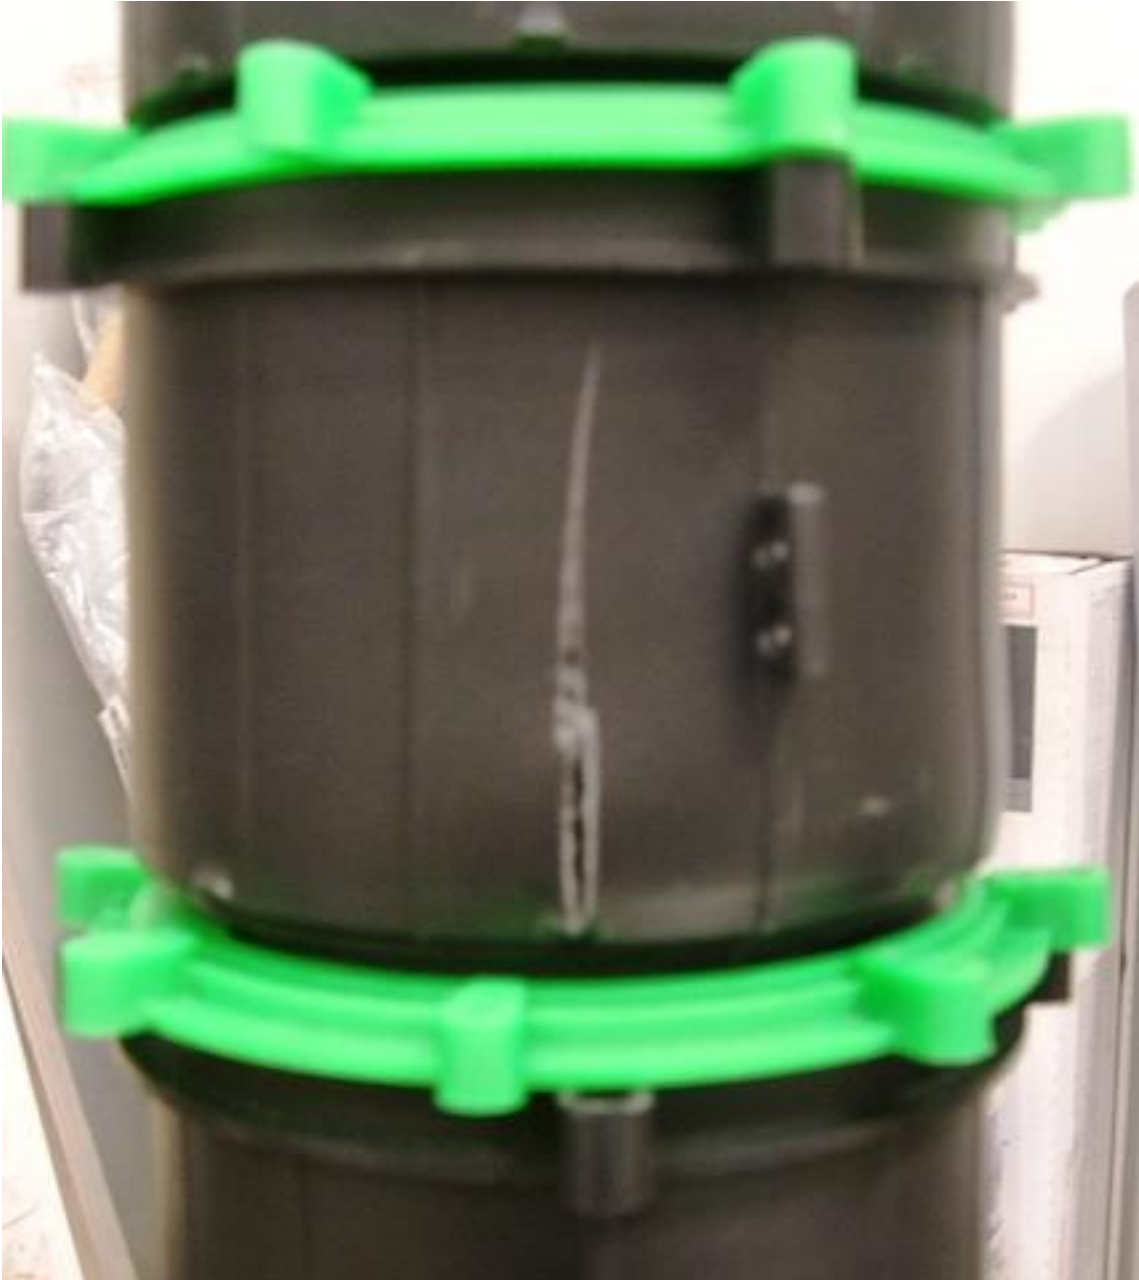
Photograph No.2  
Results of Axial Load Test on Specimen #1

| <b>Specimen No.</b> | <b>Specimen Height</b> | <b>Observations</b> |
|---|---|---|
| 1 | 22" | At a load of 2,300 pounds, the pedestals threaded collar cracked. |

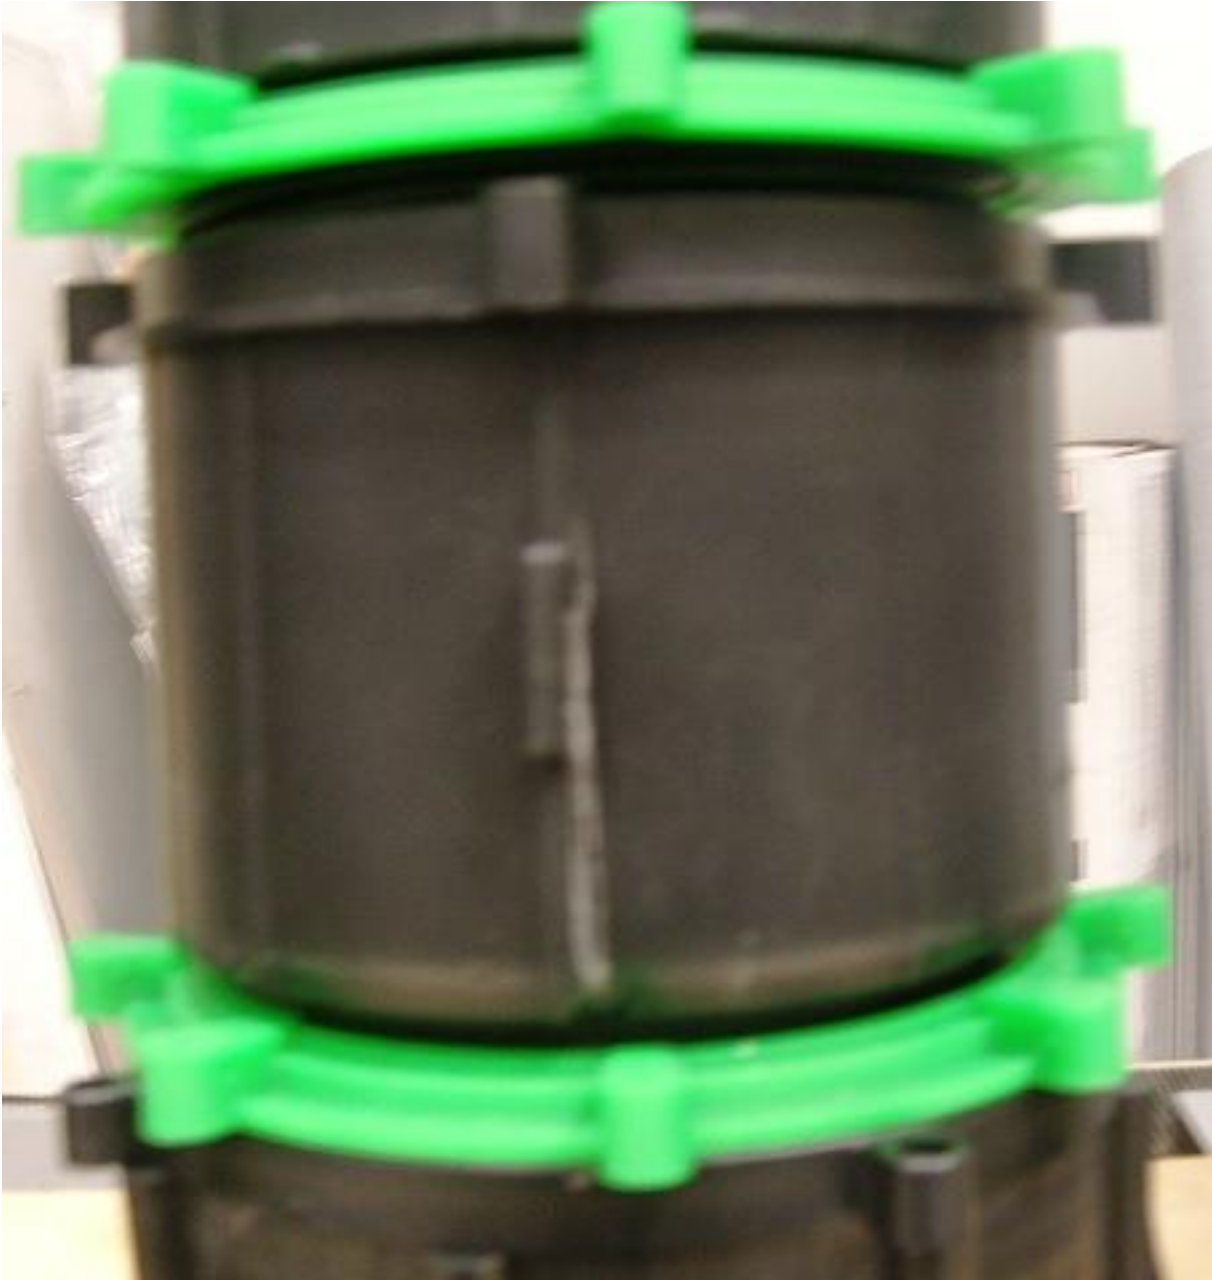
Photograph No.3  
Results of Axial Load Test on Specimen #2

| <b>Specimen No.</b> | <b>Specimen Height</b> | <b>Observations</b> |
|---|---|---|
| 2 | 22" | At a load of 2,500 pounds, the pedestals threaded collar cracked. |

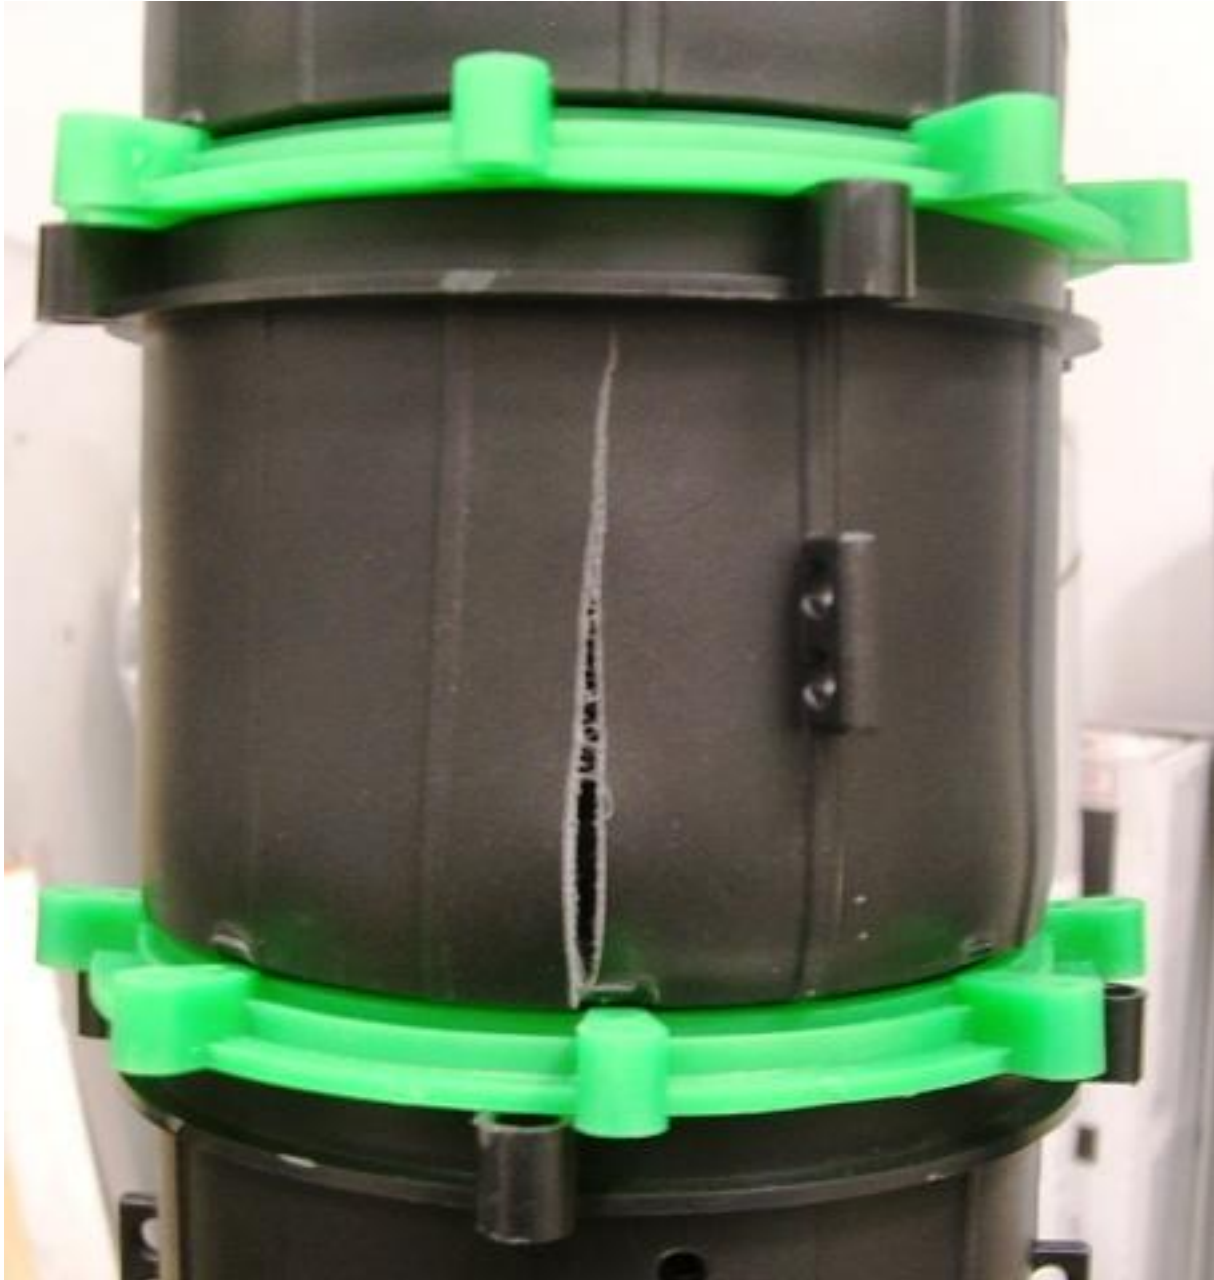
Photograph No.4  
Results of Axial Load Test on Specimen #3

| <b>Specimen No.</b> | <b>Specimen Height</b> | <b>Observations</b> |
|---|---|---|
| 3 | 22" | At a load of 2,000 pounds, the pedestals threaded collar cracked. |
