Straub Hall  
University of Oregon

# **Report #1**

## **Envelope Renovation Study**

September 2012

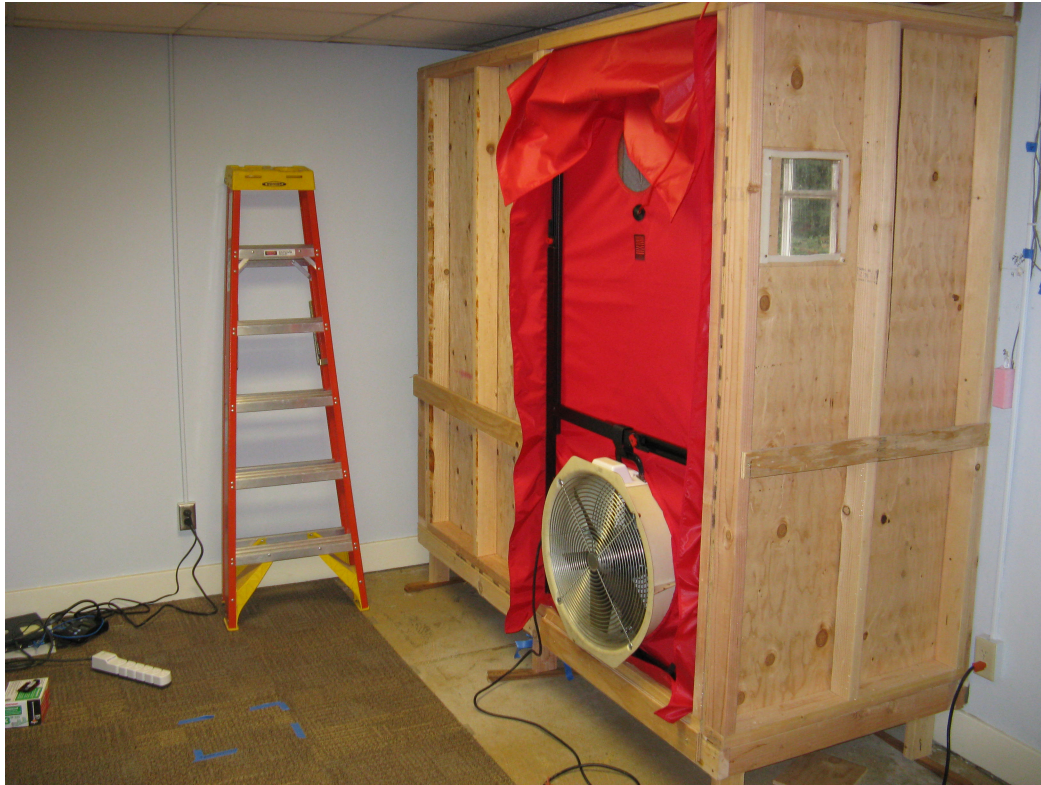
Blower door testing was conducted for each test to determine infiltration rates (see Figure 4) and infrared (IR) images were collected to visualize air cracks.

**Figure 4, Blower Door Testing in Meter Chamber**

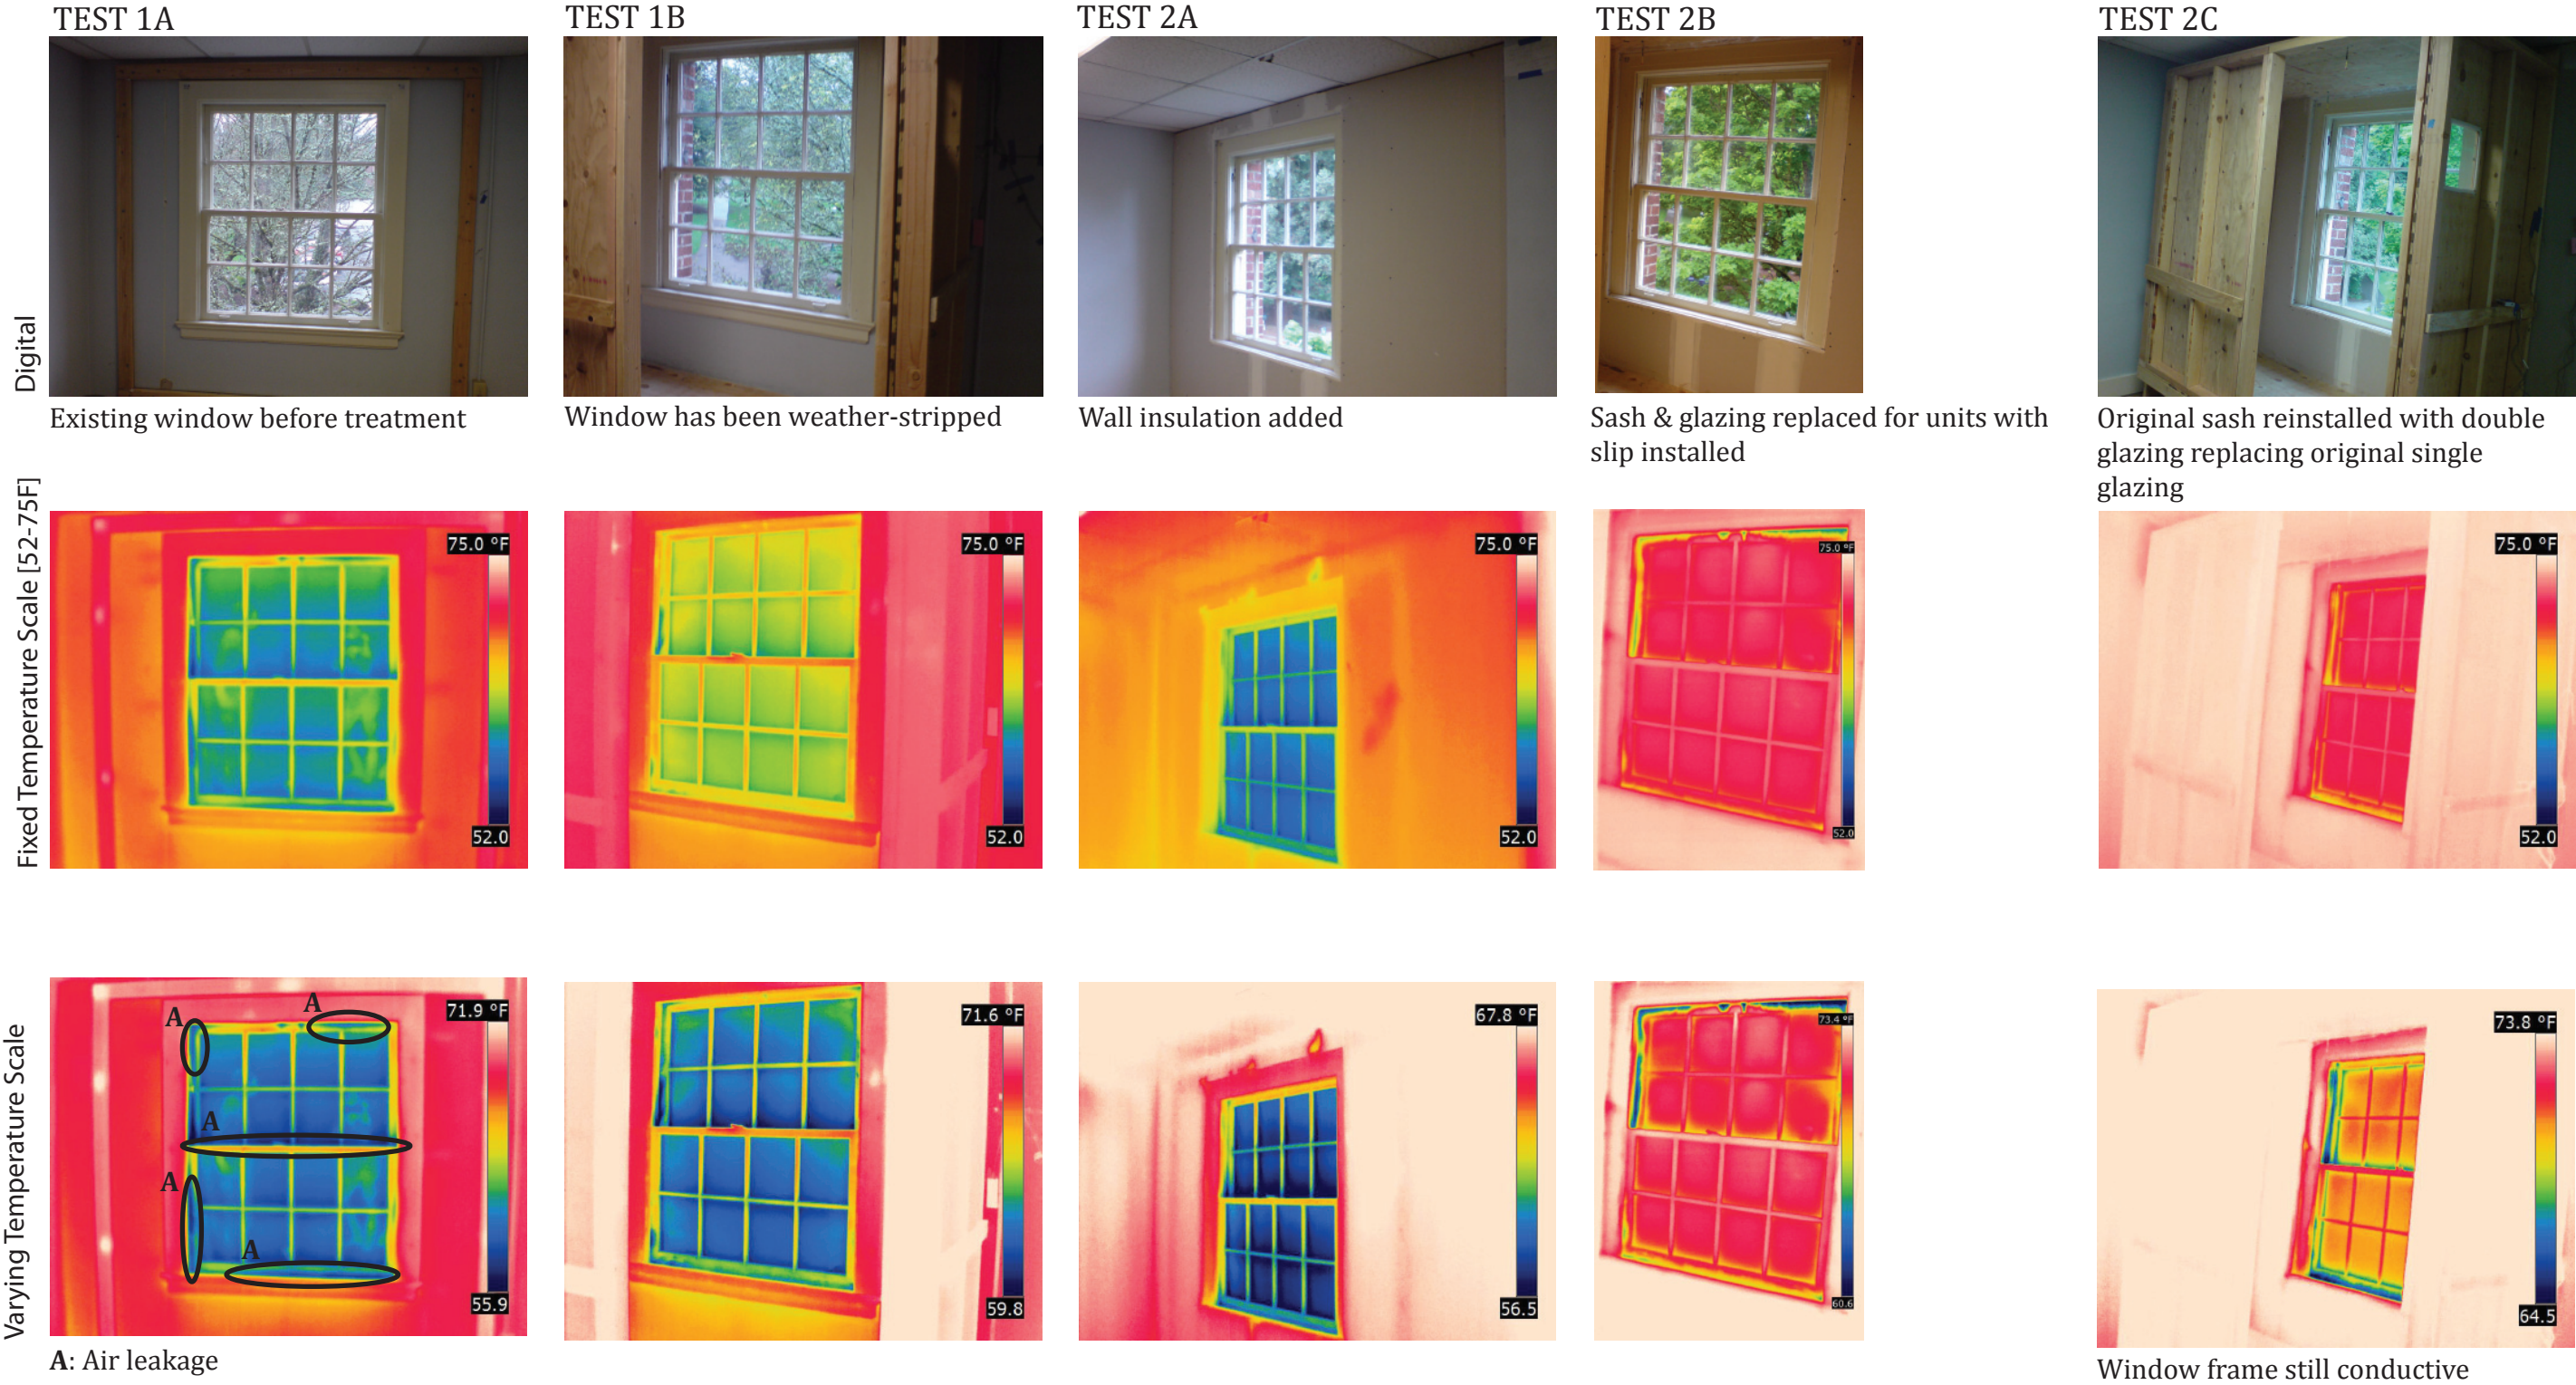
Infrared imaging was used to establish the infiltration locations around the window as well as thermal bridges in the wall assembly. The following IR images were taken during each of the tests to visualize the changes. The testing starts with the existing window and wall assemblies (1A) followed by the improvements: add weather-stripping, add wall insulation, add slips to glazing, and replace slips with double glazing.

Each column contains a visible light image and corresponding infrared images. Color represents surface temperature, with red being warmer and blue colder. There is a scale on the right edge of each image. The middle images in each column have been processed so that the temperature scales are the same for all photos, while in the lower images the scales are set to enhance the infiltration in each photo. Note that the camera is calibrated for the wall and painted wood surfaces—temperatures of the glass are not necessarily accurate.

These images were taken while depressurizing the room. Therefore, sources of infiltration can be seen where incoming cold air cools surfaces.

**Straub Hall Infiltration Tests: Whole Window and Wall**
