## TEST REPORT

No. : GZIN2311001139CM01\_EN

Sample Name : Cementitious terrazzo

Test Item: Center Point Loading Test

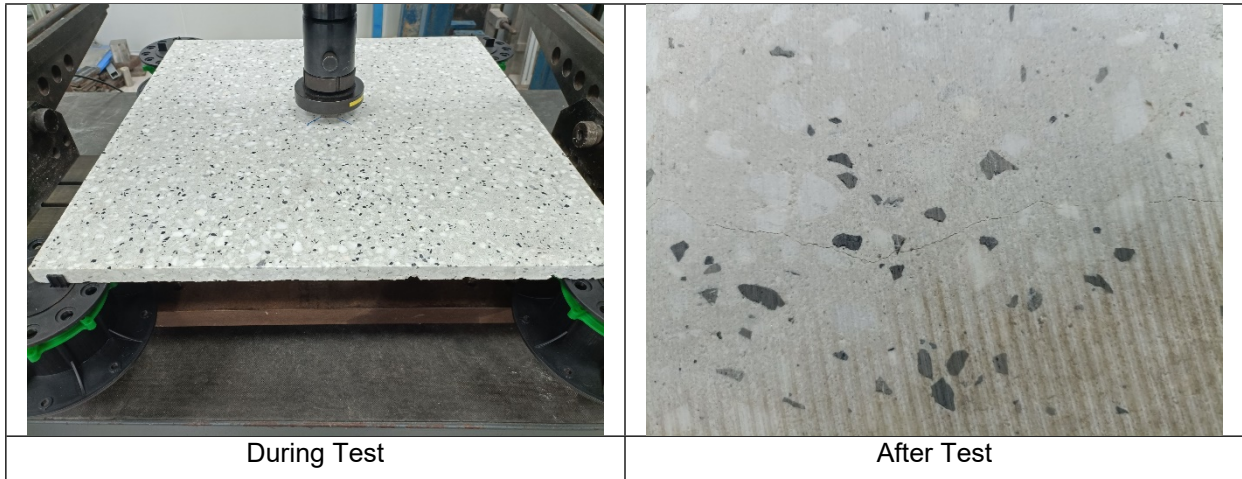
Test Photo:

Provided by client: sample was placed on a provided pedestal system. A 25mm×25mm metal plate was placed on the center of sample. Apply load on the plate until the sample break.

Specimens: 600mm×600mm×22mm

Testing speed: 5mm/min

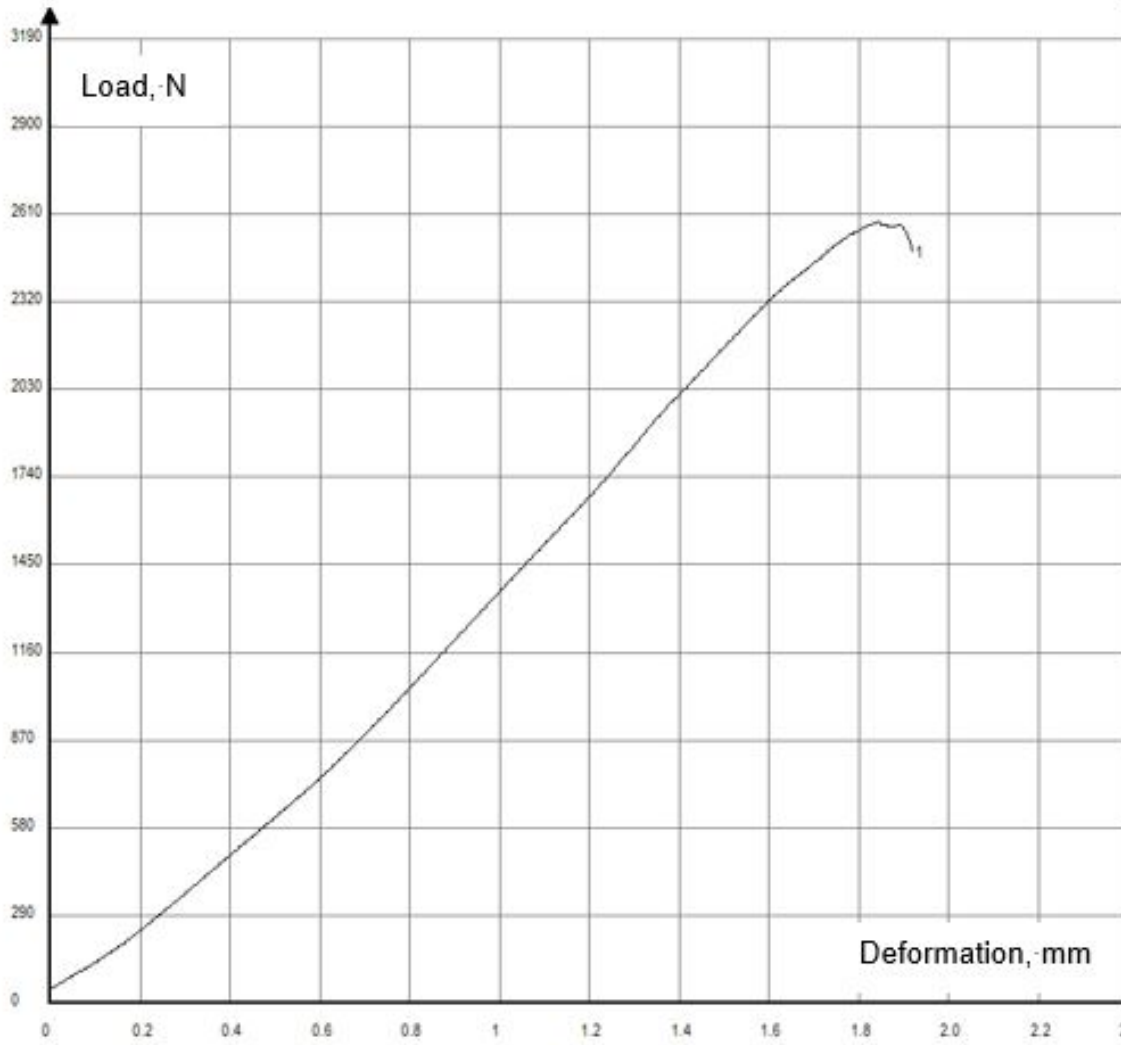
Test Curve – Specimen No. 1

| Sample | Specimen No. | Maximum Load | Failure Mode |
|---|---|---|---|
| A | 1 | 2582 | cracks on the back of the specimen |

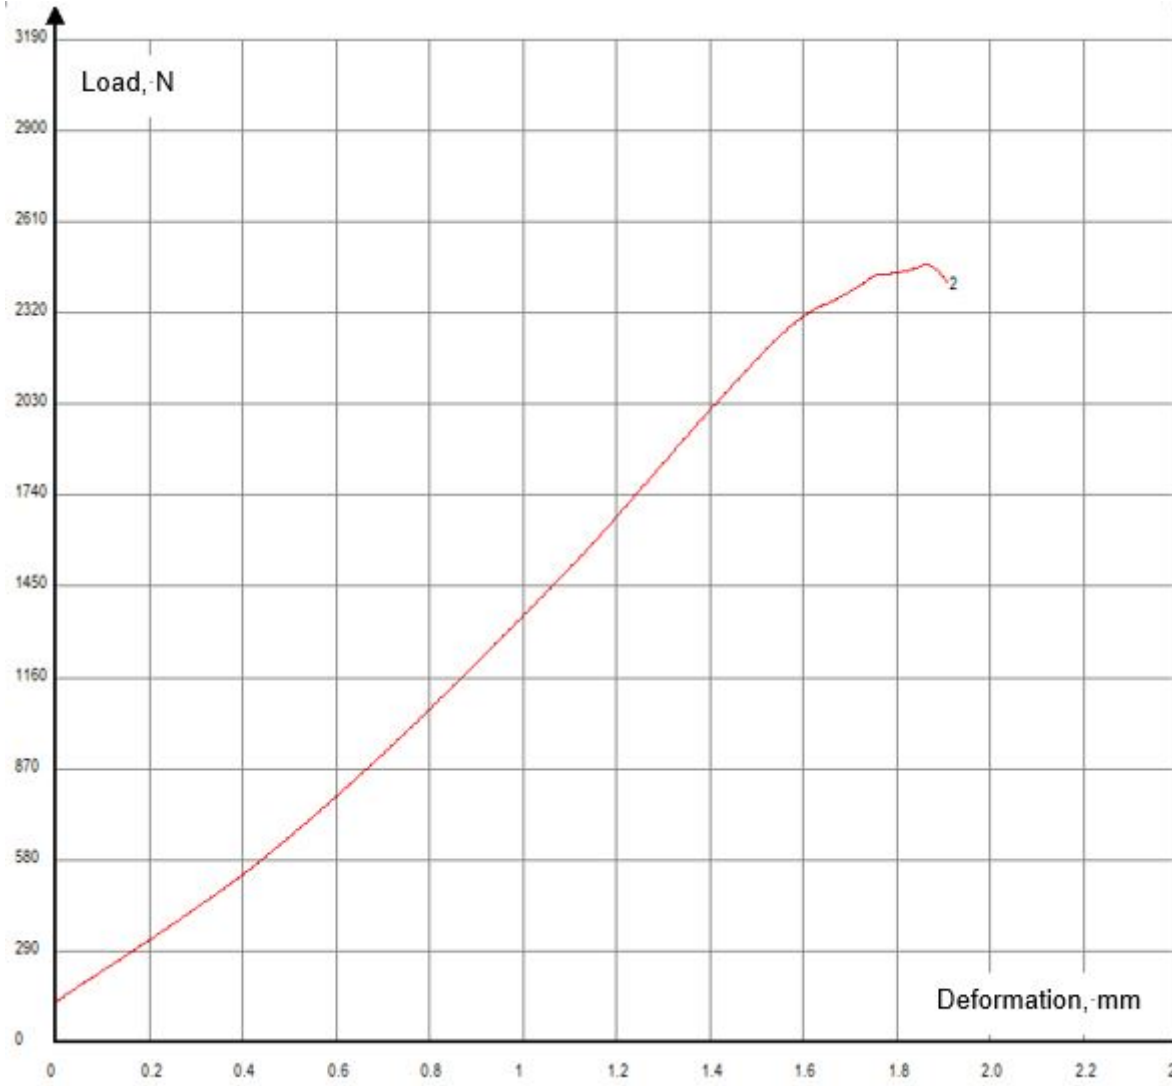
Test Curve – Specimen No. 2

| Sample | Specimen No. | Maximum Load | Failure Mode |
|---|---|---|---|
| | 2 | 2473 | cracks on the back of the specimen |

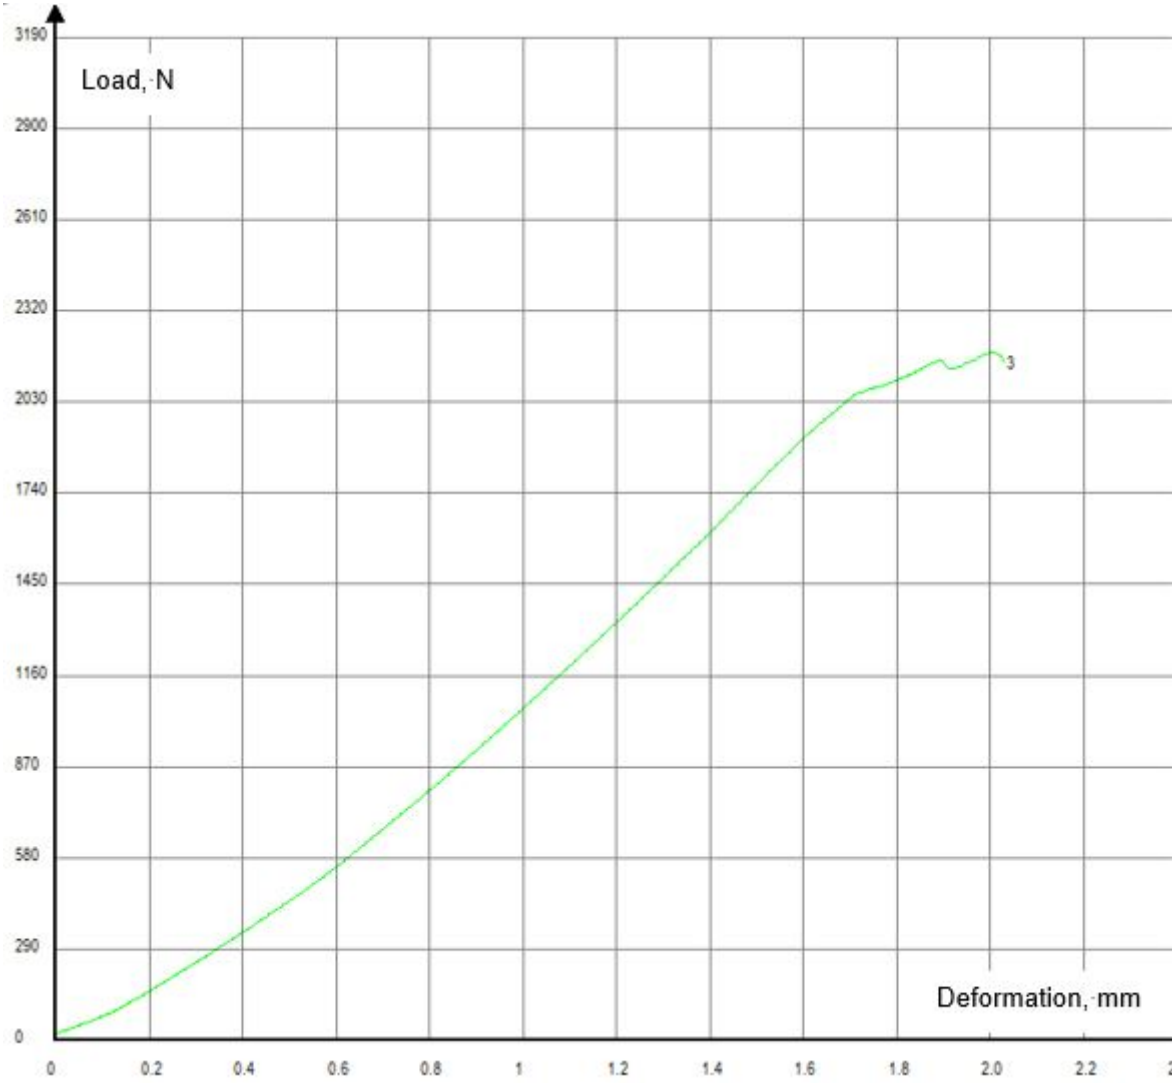
Test Curve – Specimen No. 3

| Sample | Specimen No. | Maximum Load | Failure Mode |
|---|---|---|---|
| B | 3 | 2188 | cracks on the back of the specimen |

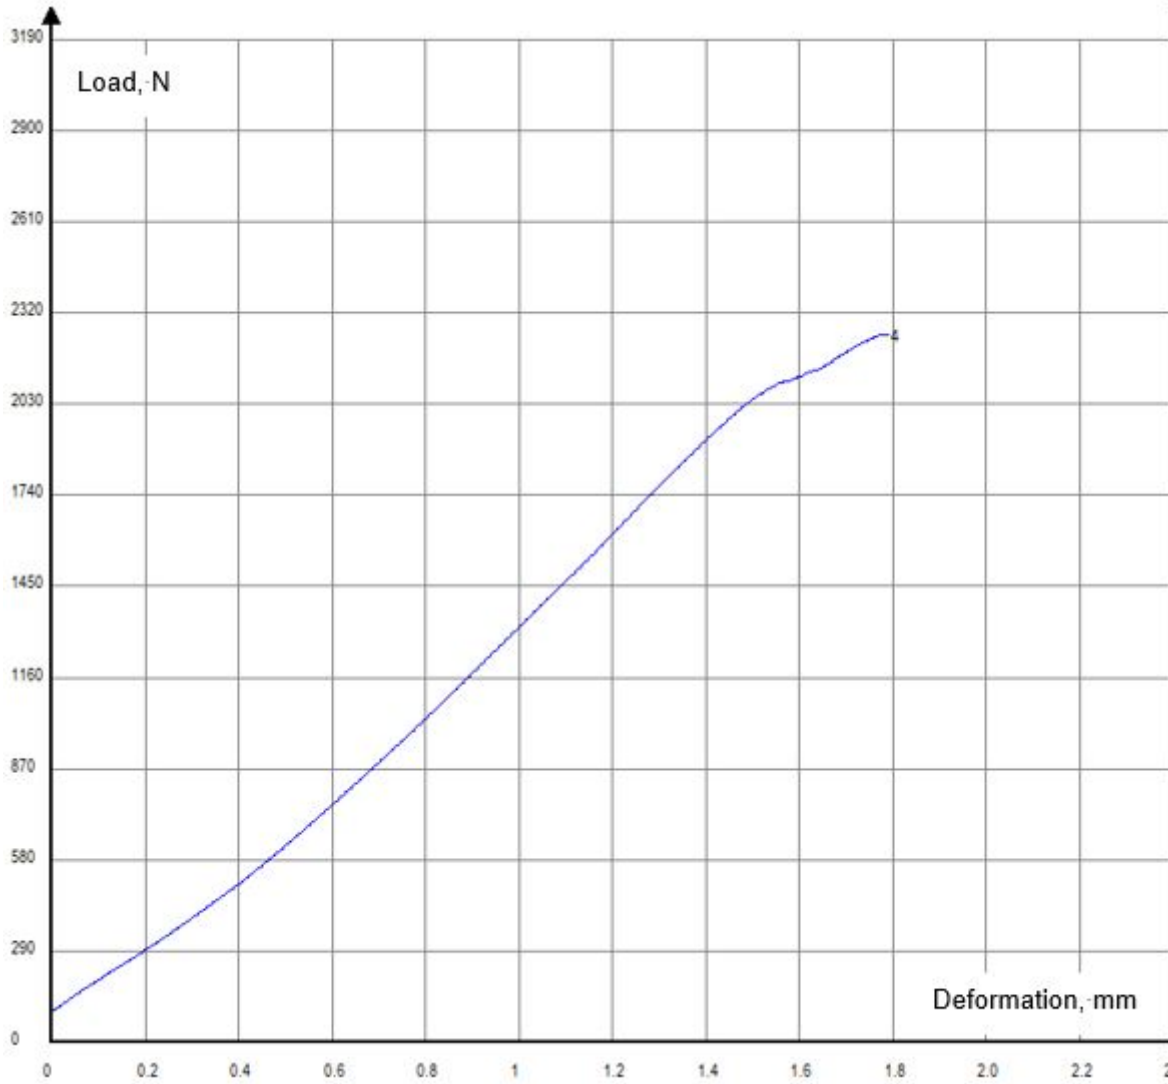
Test Curve – Specimen No. 4

| Sample | Specimen No. | Maximum Load | Failure Mode |
|---|---|---|---|
| | 4 | 2251 | cracks on the back of the specimen |

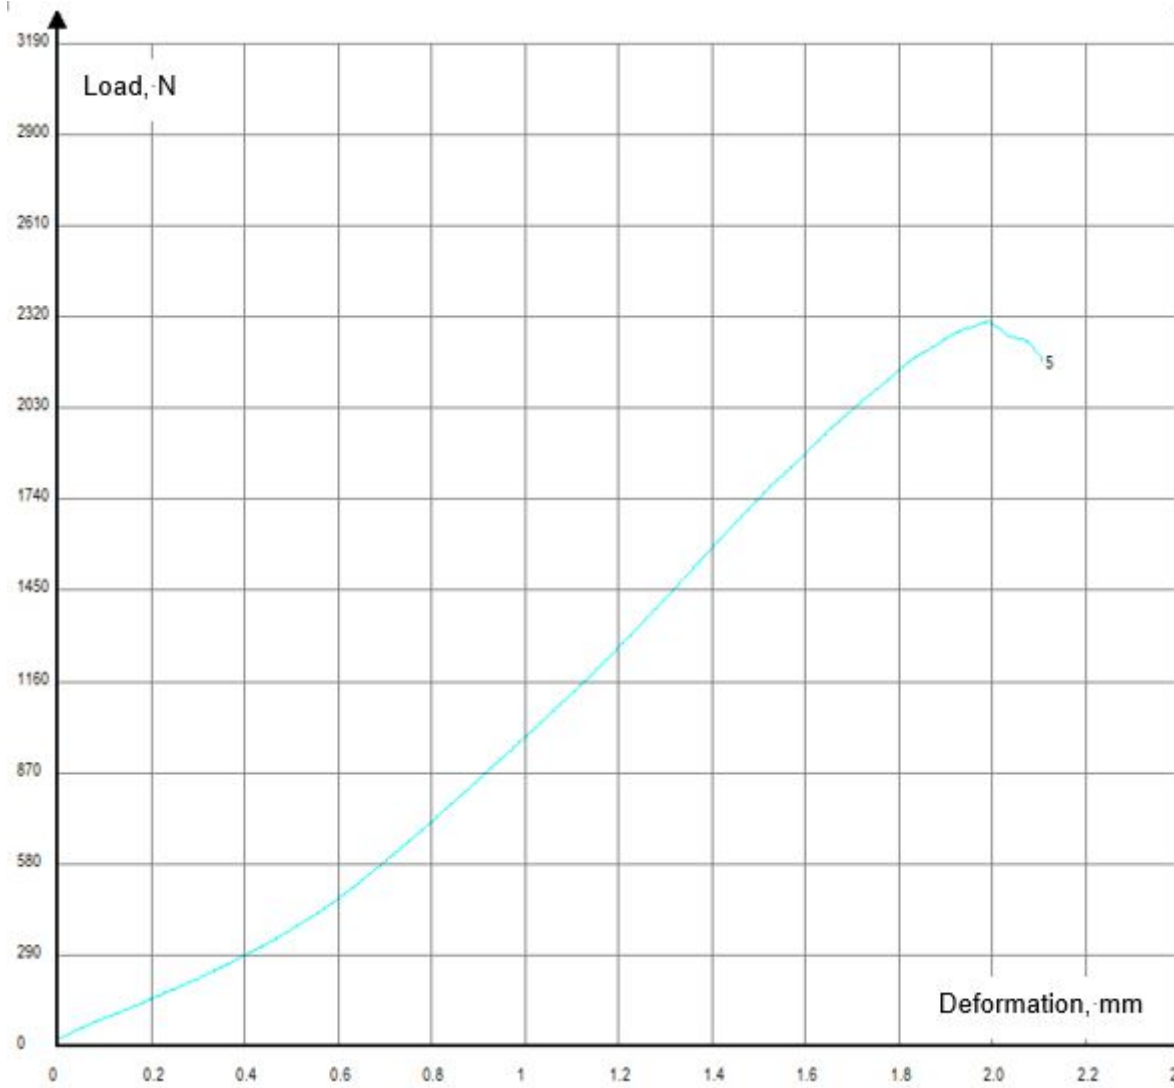
Test Curve – Specimen No. 5

| Sample | Specimen No. | Maximum Load | Failure Mode |
|---|---|---|---|
| C | 5 | 2304 | cracks on the back of the specimen |

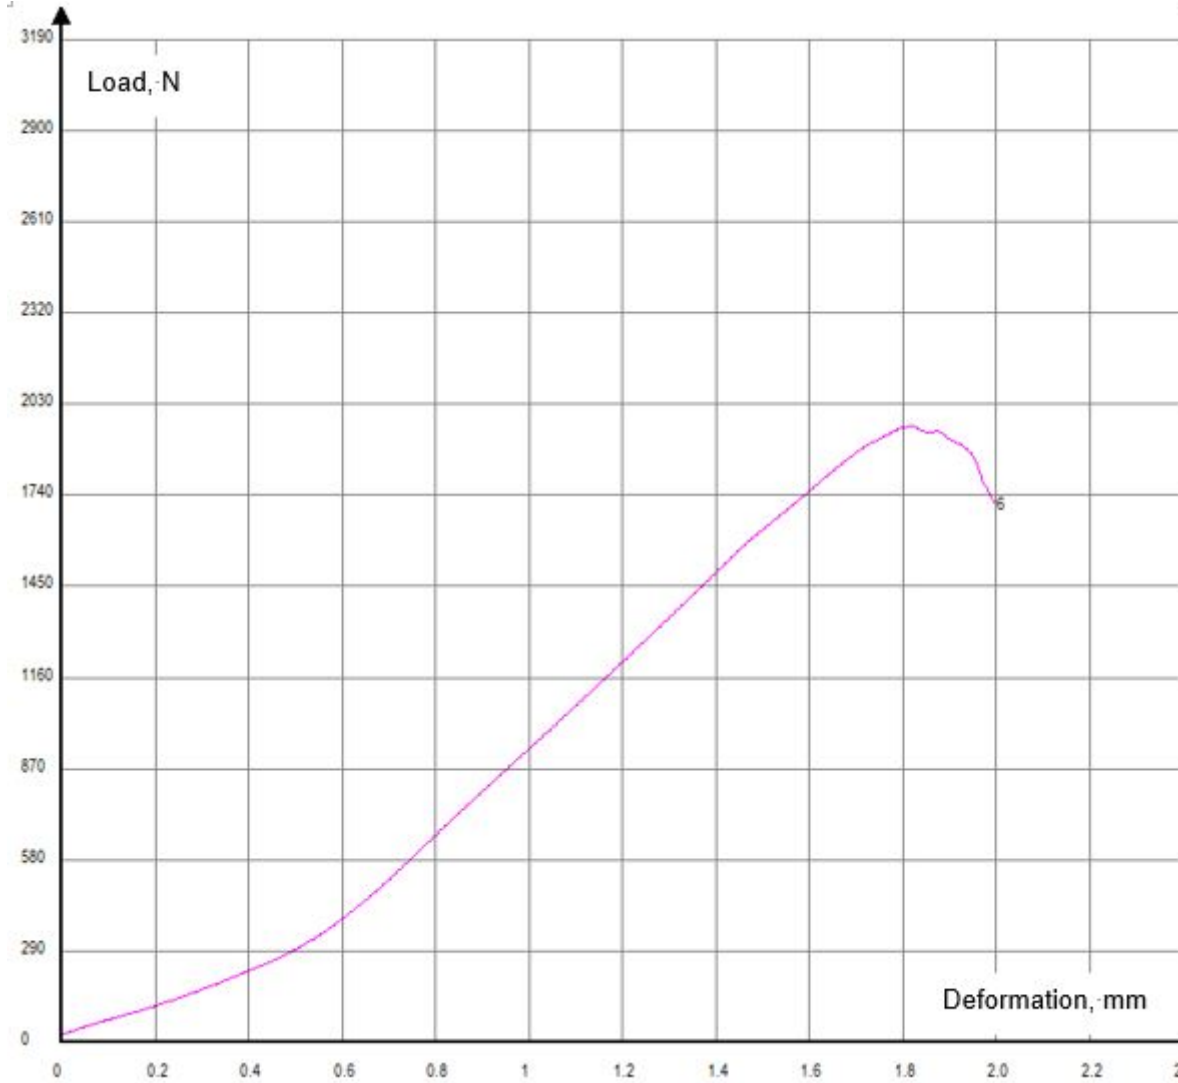
Curve – Specimen No. 6

| Sample | Specimen No. | Maximum Load | Failure Mode |
|---|---|---|---|
| | 6 | 1959 | cracks on the back of the specimen |
